# Manhole Inspection Summary

Manhole # S61Q\_\_005MH

Insp Date: **9/1/09 2:07 PM**

**Location** Address: **1600 BLOCK PONCA ST.**

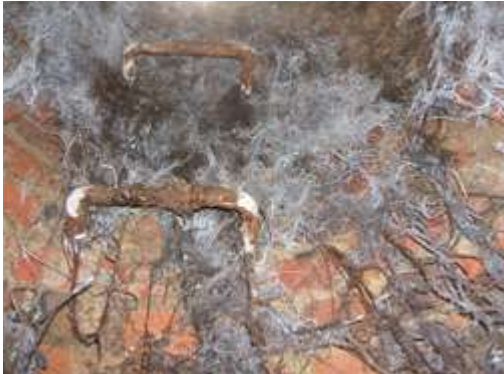
Defect 1

Condition: ☐ Sound ☐ Cracked ☒ **Root Intrusion** ☐ Loose Brick ☐ Deteriorated

Infiltration: ☐ None ☒ **Joint** ☐ Cracks ☐ Mortar ☒ **Roots** ☐ Wall

ROOTS IN BARREL

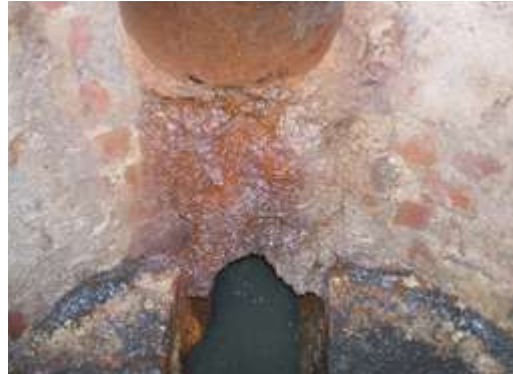
Defect 2

Comments **NRV2 - DRIPPER GROUNDWATER ON I6. THIS WAS A BURIED MH, VERIFIED BY RECORD DRAWINGS (BS-80-36618) LOCATED AND RAISED TO GRADE BY REI [082009 RES]**

CRACKED PIPE SEAL AND GROUND WATER EVIDENCE OVER I6

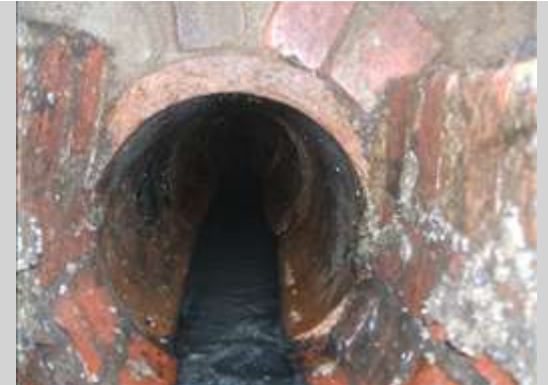
12 O'Clock Outflow

Pipe Height: (in.) Direct  
Pipe Material: **Clay** ☐ Pipe Lined  
Invert Depth: **12.06** (ft.) Flow Characteristics: **Slow**  
Deposits: ☒ None ☐ Mud ☐ Sludge ☐ Debris ☐ Grease  
Silt Depth: (in.) Deposits Extent:  
Infiltration: **None** Pipe Seal Cond: **Sound**

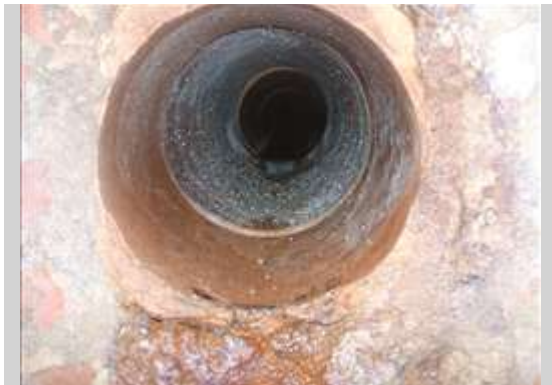
6 O'Clock Inflow

Pipe Height: (in.) Direct  
Pipe Material: **Clay** ☐ Pipe Lined  
Invert Depth: **12.02** (ft.) Flow Characteristics: **Slow**  
Deposits: ☒ None ☐ Mud ☐ Sludge ☐ Debris ☐ Grease  
Silt Depth: (in.) Deposits Extent:  
Infiltration: **Evidence** Pipe Seal Cond: **Cracked**

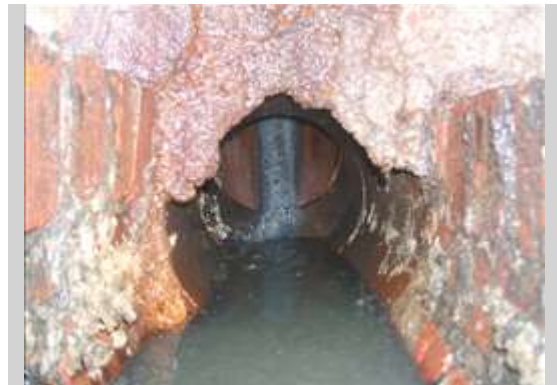
Drop In @ 6 O'Clock

Drop: **Outside Direct**  
Angled: Reading: (ft.)  
Inv Depth: **10.25** (ft.)  
Drop Condition: **Open**
